CRITERION HOME INSPECTIONS

Inspection Report

Property Address: 73rd Street Brooklyn NY 11209

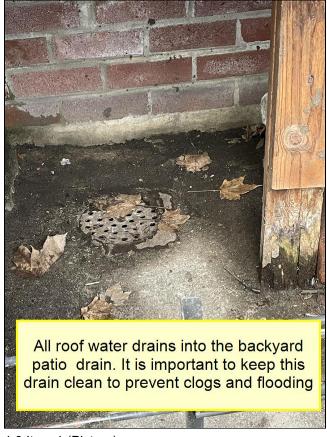
1.0 Item 1 (Picture)

All roof water drains into the backyard patio drain. It is important to keep this drain clean to prevent clogs and flooding

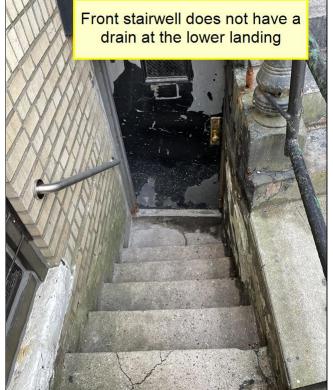
1.0 Item 2 (Picture)

Front stairwell does not have a drain at the lower landing

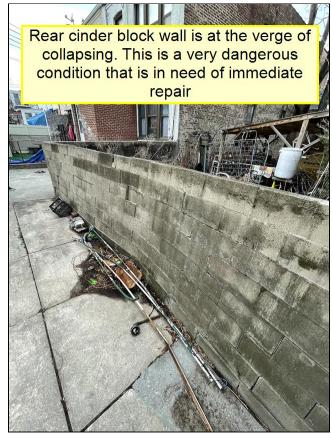
1.1 Item 1 (Picture)

Rear cinder block wall is at the verge of collapsing. This is a very dangerous condition that is in need of immediate repair

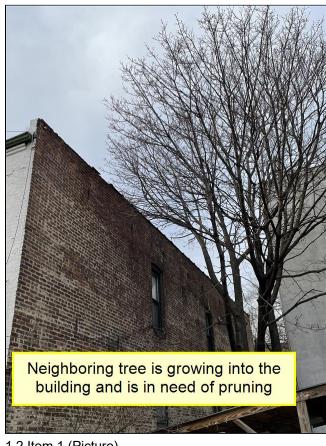
1.2 Item 1 (Picture)

Neighboring tree is growing into the building and is in need of pruning

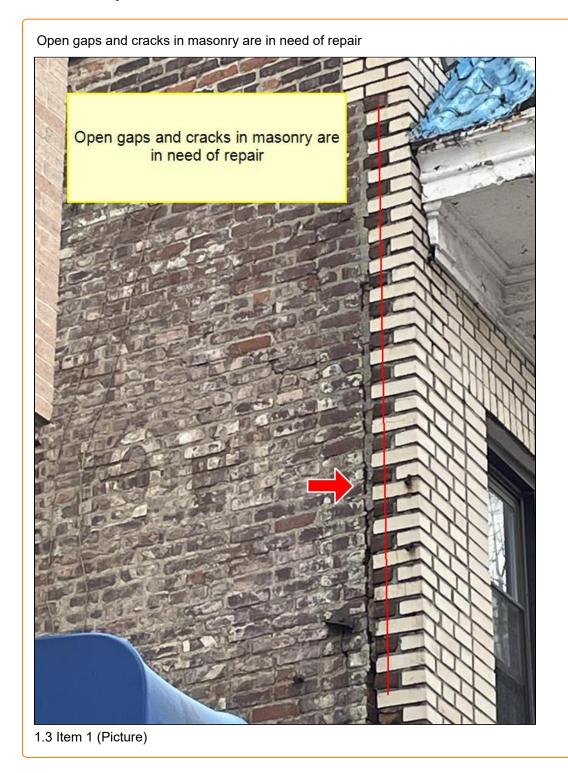
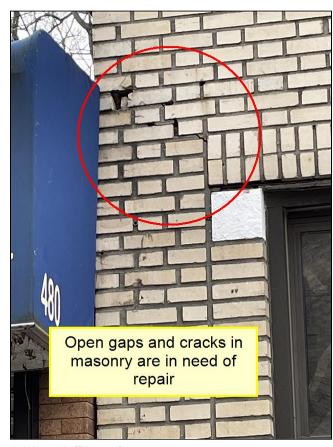
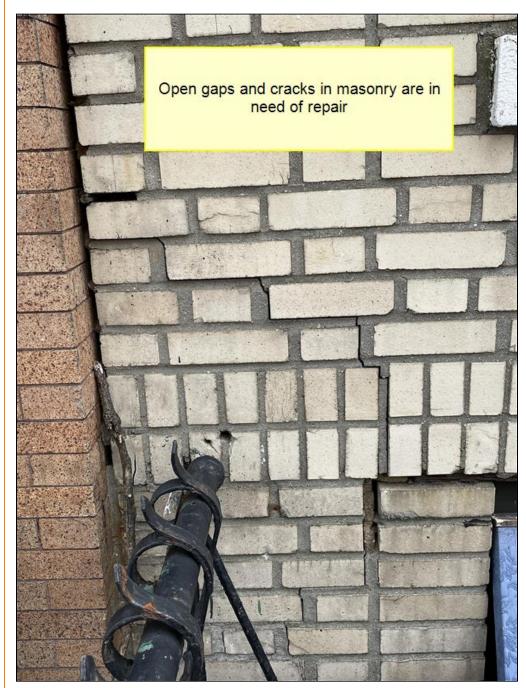
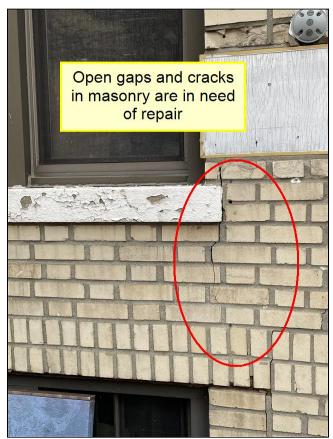
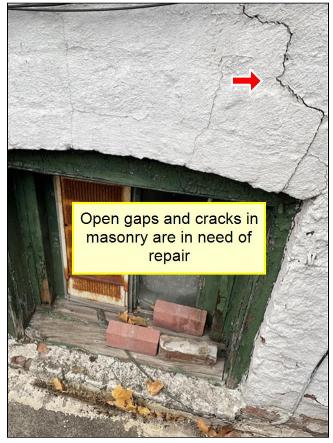
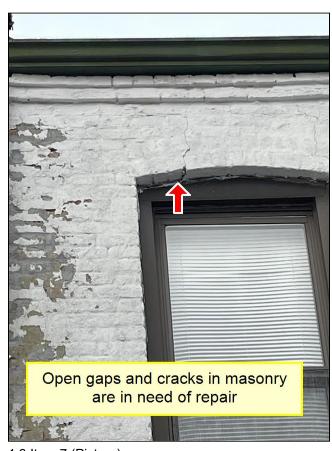
Open gaps and cracks in masonry are in need of repair

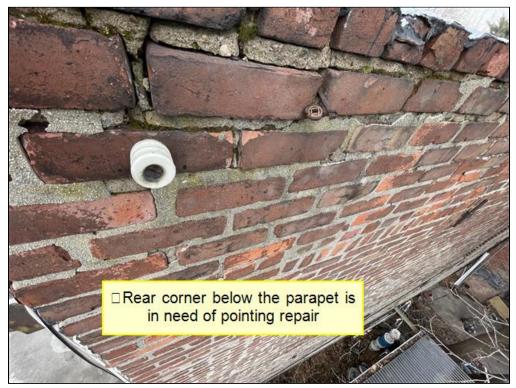
1.4 Item 1 (Picture)

Brick pointing is in overall good condition, but rear corner below the parapet is in need of pointing repair

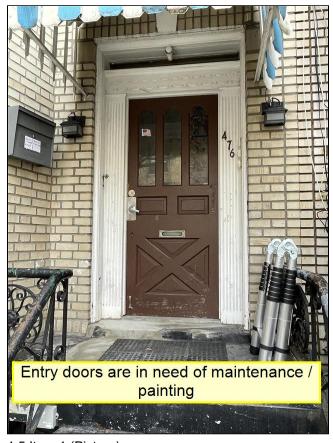
1.5 Item 1 (Picture)

Entry doors are in need of maintenance / painting

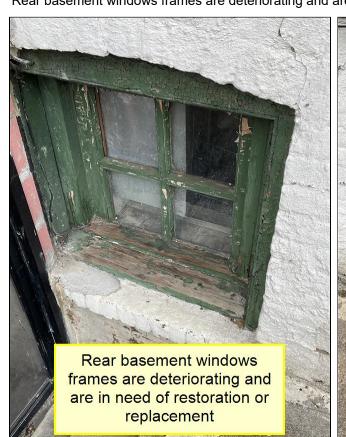
Rear basement windows frames are deteriorating and are in need of restoration or replacement

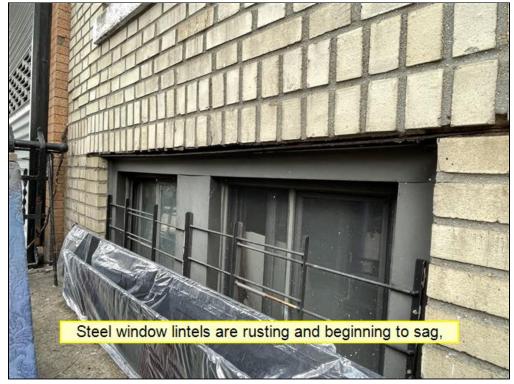
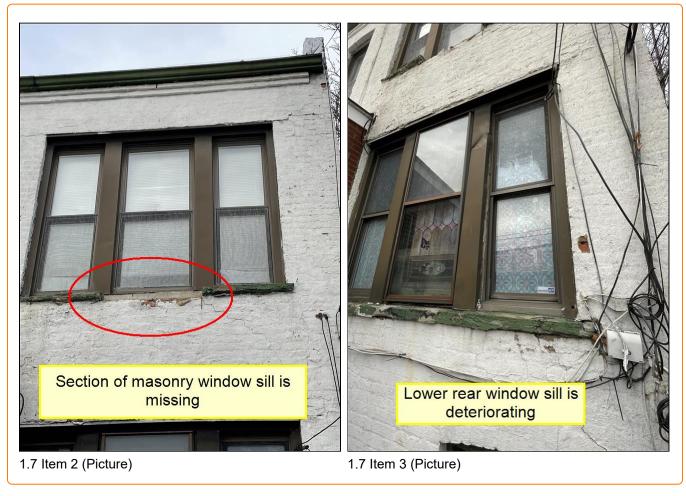
1.7 Item 1 (Picture)

Steel window lintels are rusting and beginning to sag, This is not a structural at this time, but they should be monitored and replacement should be part of a long term maintenance schedule. At this time they should be painted to prevent further corrosion

Section of rear 2nd floor masonry window sill is missing

Lower rear masonry window sill is deteriorating

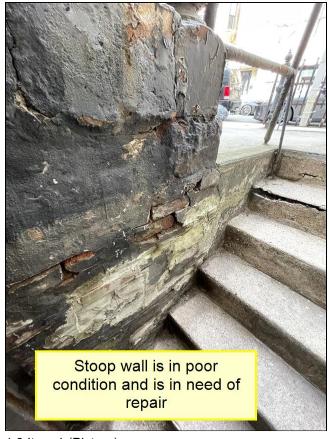
1.8 Item 1 (Picture)

Stoop wall is in poor condition and is in need of repair

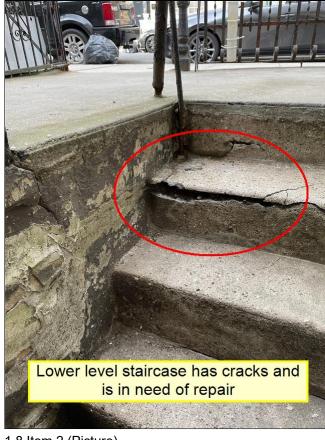
1.8 Item 2 (Picture)

Lower level staircase has cracks and is in need of repair

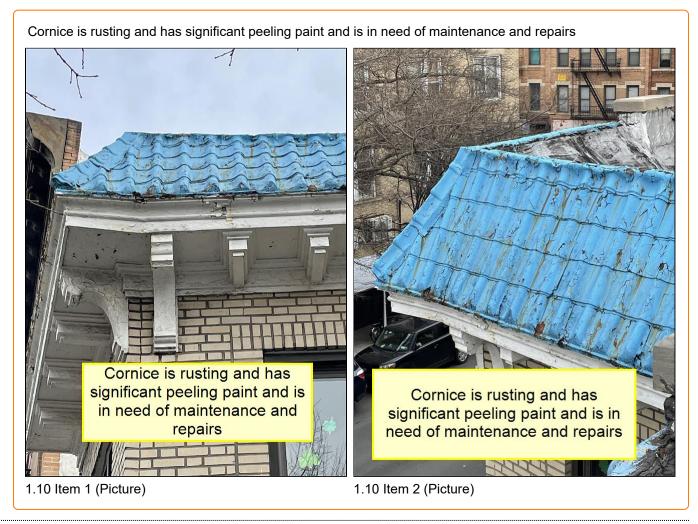
Cornice is rusting and has significant peeling paint and is in need of maintenance and repairs

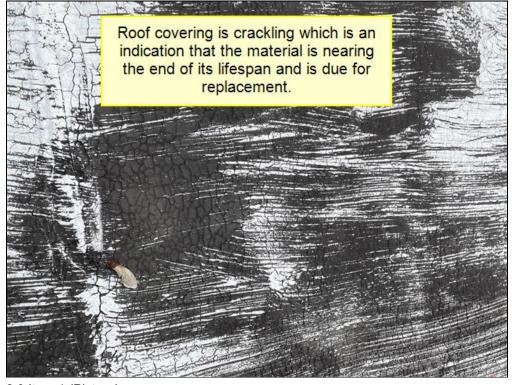
2.0 Item 1 (Picture)

(1) Roof covering is crackling which is an indication that the material is nearing the end of its lifespan and is due for replacement.

An application of roofing cement at all seams and an application of aluminium coating can help extend the life of the roof, but roof replacement should be part of a building maintenance schedule

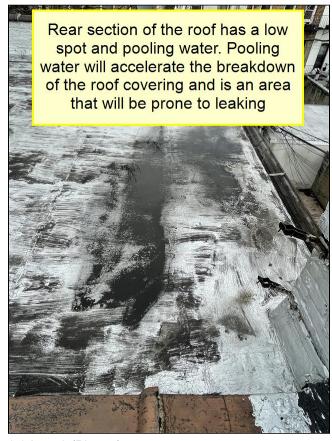
2.0 Item 2 (Picture)

Rear section of the roof has a low spot and pooling water. Pooling water will accelerate the breakdown of the roof covering and is an area that will be prone to leaking

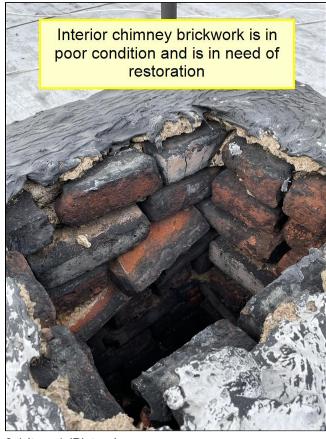
2.1 Item 1 (Picture)

Interior chimney brickwork is in poor condition and is in need of restoration,

Falling debris into the chimney can clog flue pipe and boiler exhaust and potentially cause the release of carbon monoxide into the living space

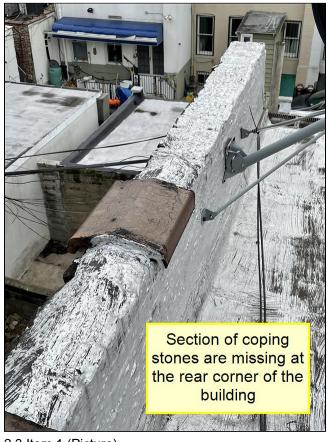
2.3 Item 1 (Picture)

Section of coping stones are missing at the rear corner of the building

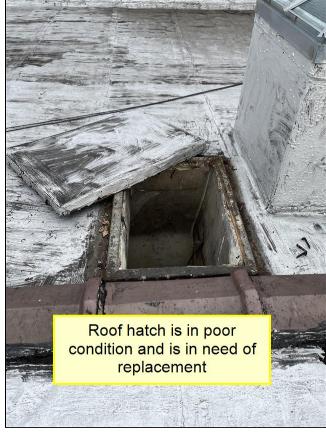
2.4 Item 1 (Picture)

Roof hatch door should be upgraded to a metal hatch with a hydraulic lift when renovations are performed

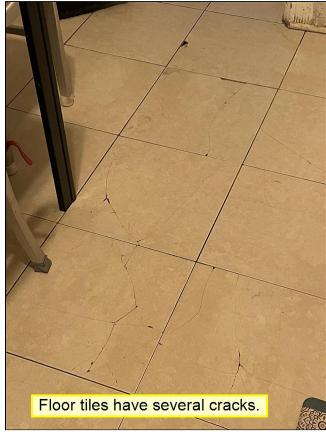
3.2 Item 1 (Picture)

Floor tiles have several cracks.

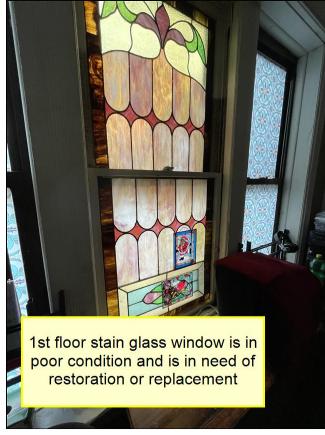
3.6 Item 1 (Picture)

1st floor stain glass window is in poor condition and is in need of restoration or replacement

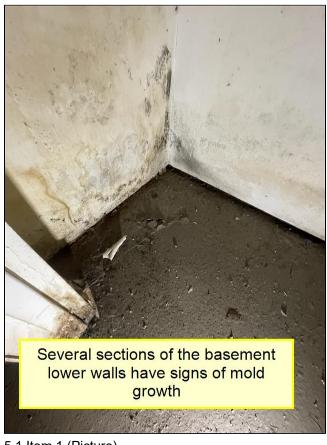
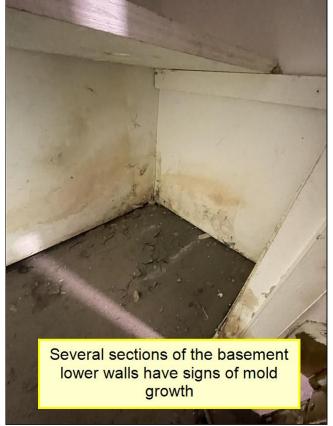
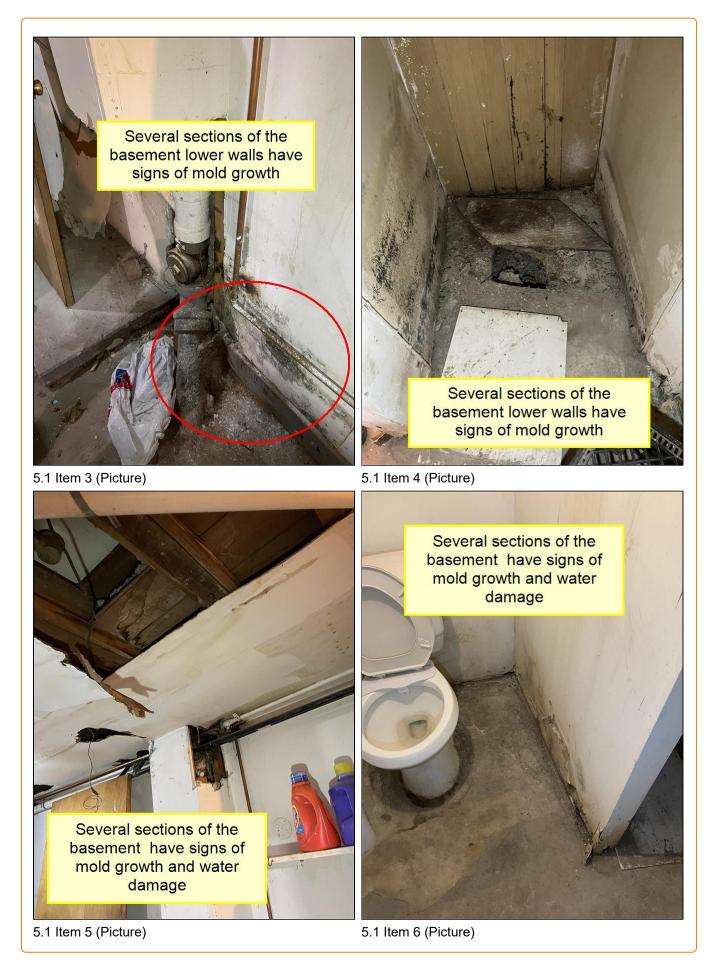
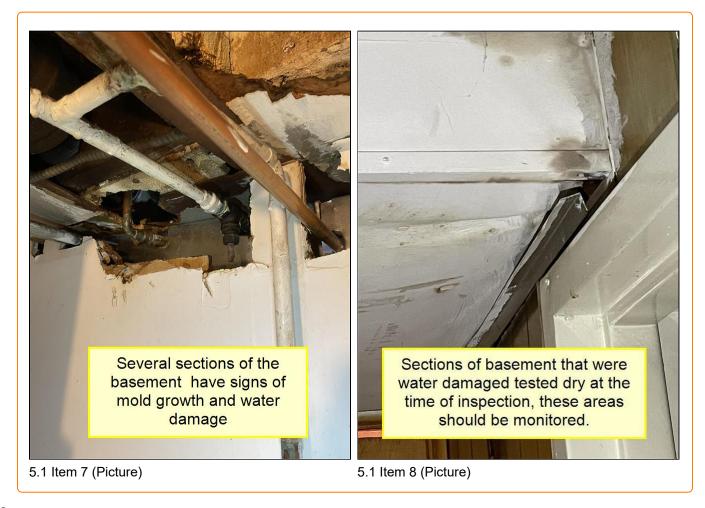
Several sections of the basement have signs of mold growth and water damage

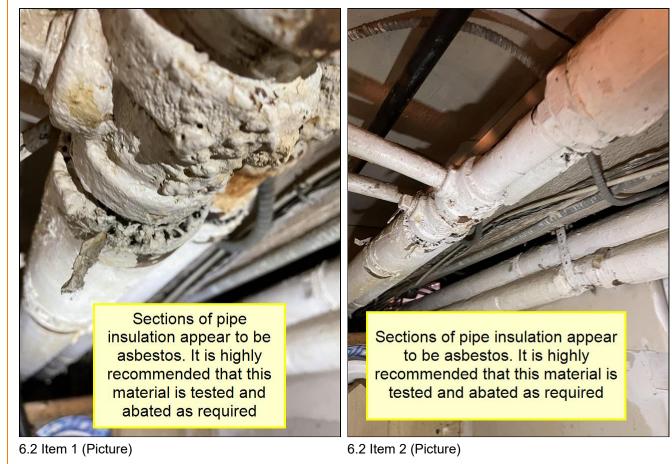
Sections of pipe insulation appear to be asbestos. It is highly recommended that this material is tested and abated as required

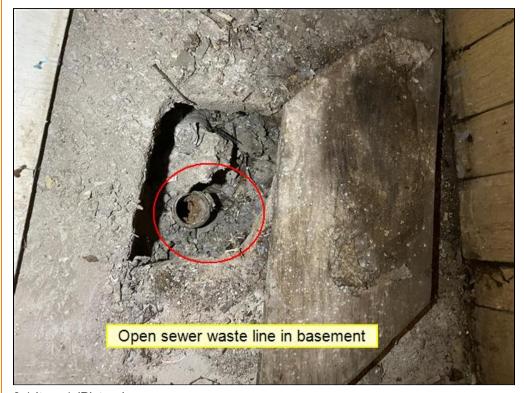
8.1 Item 1 (Picture)

Open sewer waste line in basement

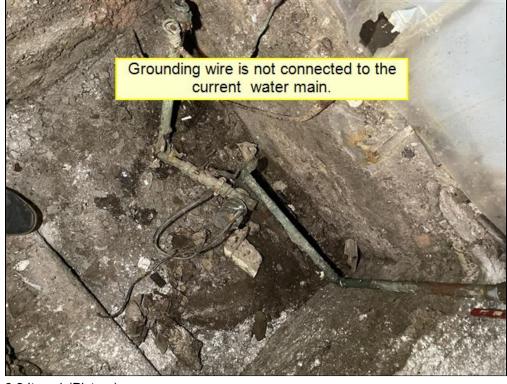
9.2 Item 1 (Picture)

Grounding wire is not connected to the water main. This creates a hazardous condition and should be repaired immediately

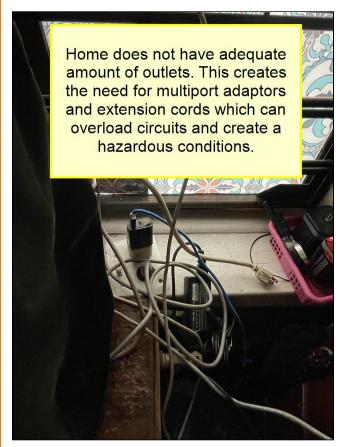
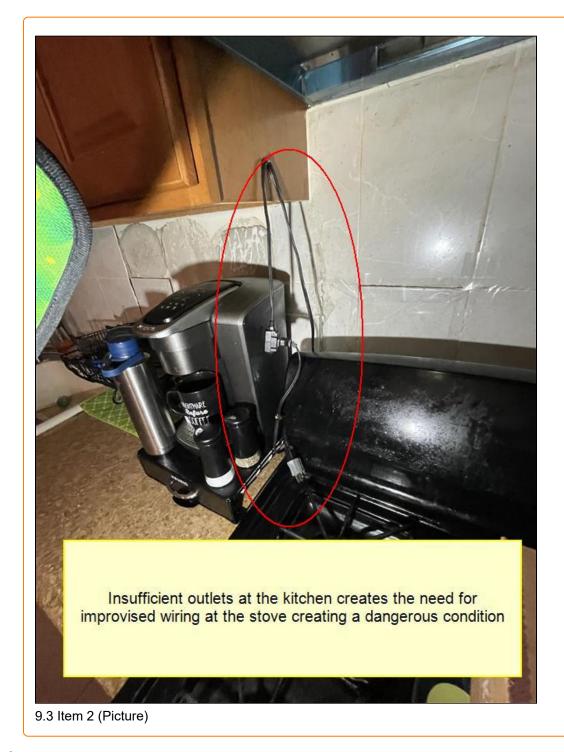
9.3 Item 1 (Picture)

Insufficient outlets at the kitchen creates the need for improvised wiring at the stove creating a dangerous condition

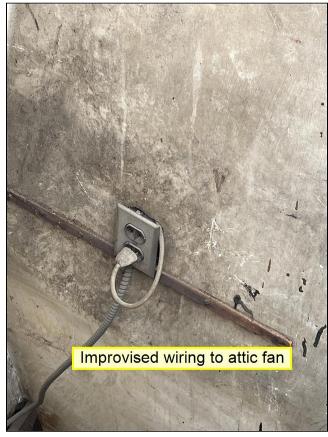
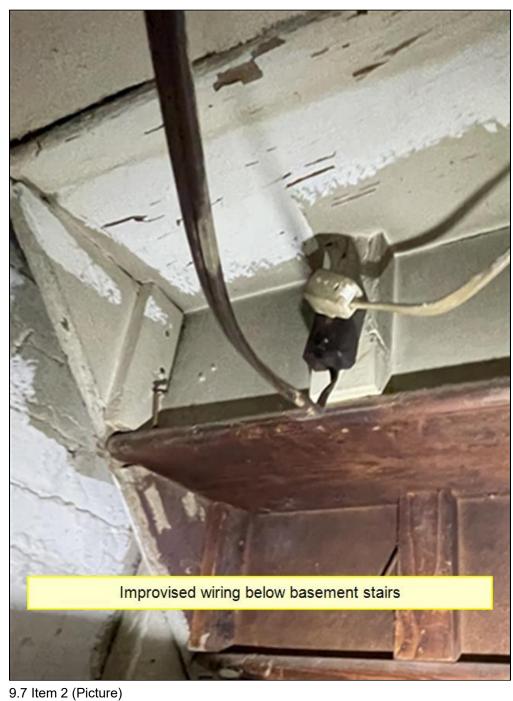
9.7 Item 1 (Picture)

Improvised wiring to attic fan

Improvised wiring below basement stairs

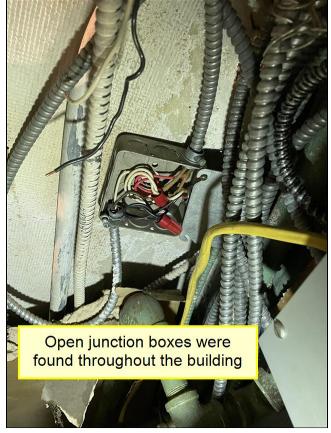
9.8 Item 1 (Picture)

73rd Street Page 46 of 57 Open junction boxes were found throughout the building

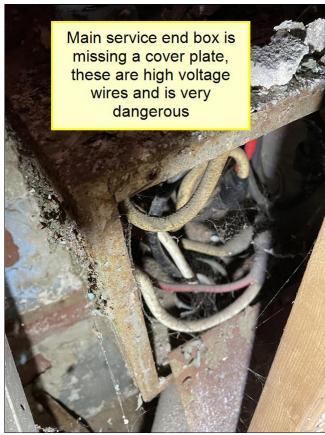
9.8 Item 2 (Picture)

Main service end box is missing a cover plate, these are high voltage wires and is very dangerous

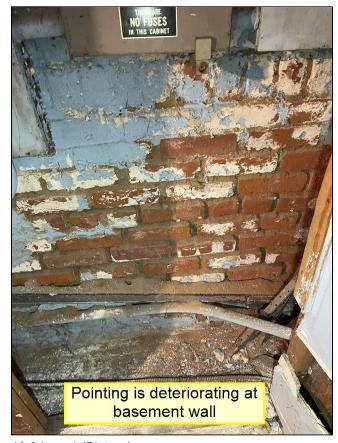
10.0 Item 1 (Picture)

Pointing is deteriorating at basement wall

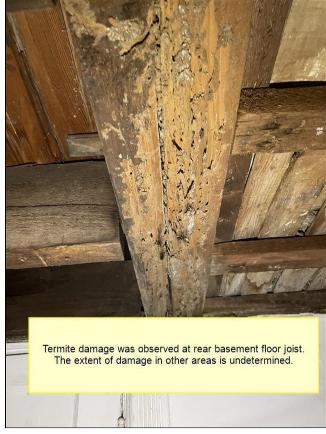
10.3 Item 1 (Picture)

Termite damage was observed at basement floor joists. The extent of damage in other areas is undetermined. It is highly recommended that a pest management company is brought in to begin a treatment program
